# Invasive Species Impacts on Transportation INFRASTRUCTURE

U.S. Department  
of Transportation  
**Federal Highway  
Administration**

1. Report No. FHWA-HEP-23-021	2. Government Accession No	3. Recipient's Catalog No.	
4. Title and Subtitle Invasive Species Impacts on Transportation Infrastructure		5. Report Date November 2021

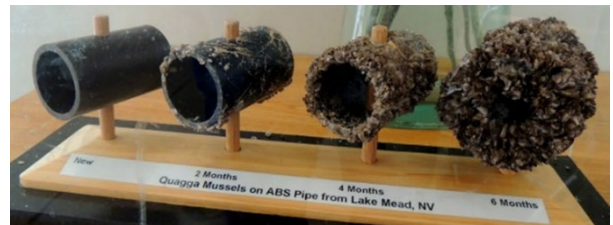
**This is how much invasive quagga mussels can clog a pipe in 6 months.**

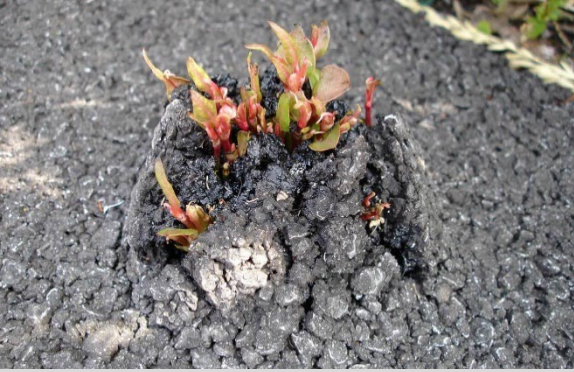
**Japanese knotweed growing up through pavement.**

Japanese knotweed damages and weakens the structural integrity of man-made features such as bridge abutments, roads, sidewalks, parking lots, and foundations. As their roots increase in diameter, they exert pressure weakening and cracking structures. The roots can damage subsurface drainage, underground conduits, septic systems, and other subsurface infrastructure.

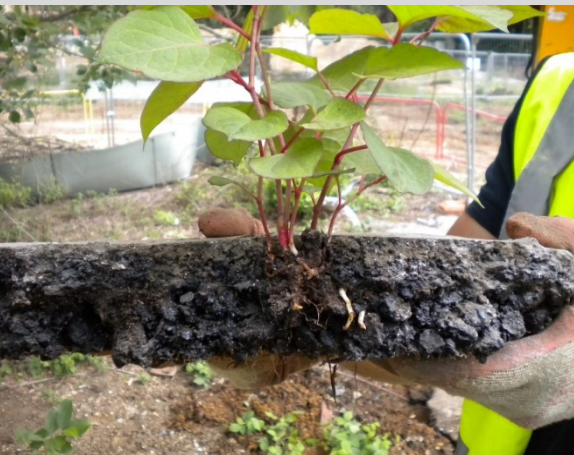
**Japanese knotweed roots growing through pavement.**

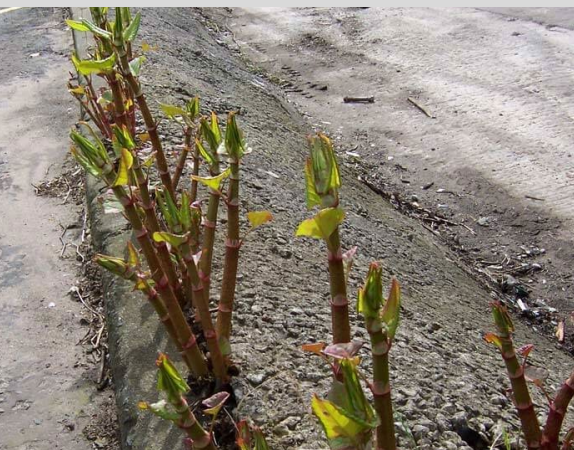
**Japanese knotweed growing along a reinforced embankment**

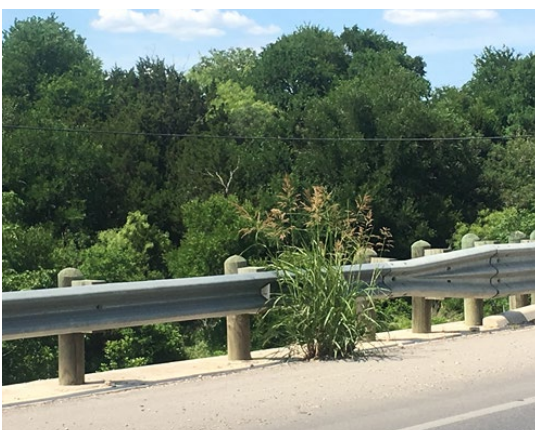
**Invasive johnsongrass (*Sorghum halepense*) growing in edge of pavement.**

Invasive plants will establish and grow in pavement cracks, joints of mechanically stabilized earth (MSE) walls, and other tiny openings in infrastructure, damaging and weakening these areas causing structural failures and shortening infrastructure life span. Like Japanese knotweed, many plants are even the underlying cause of cracks. Once these plants get a foot hold they make a small problem worse. They increase the rate in which pavement cracks expand, and as they grow, the resulting damage leaves openings for more invasive species to establish, exponentially increasing the damage. They decrease the life of roadway pavement, and they weaken joints of MSE walls associated with overpasses, bridges, and roadway embankments.

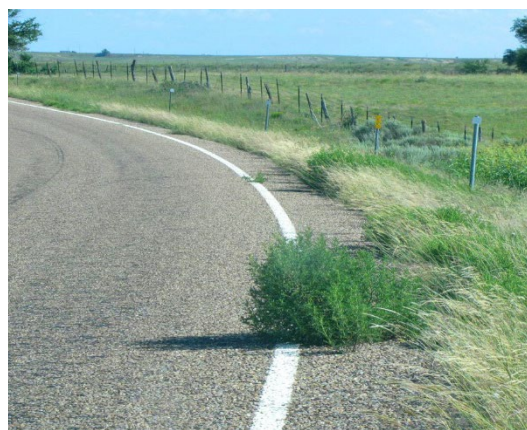
**Kochia (*Kochia scoparia*) growing in pavement.**

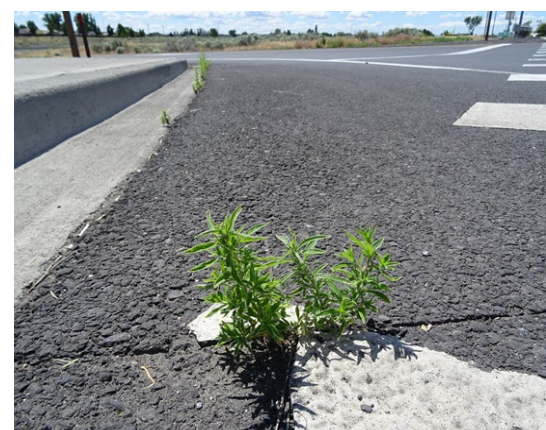
**Kochia growing in pavement seam and edge of pavement.**

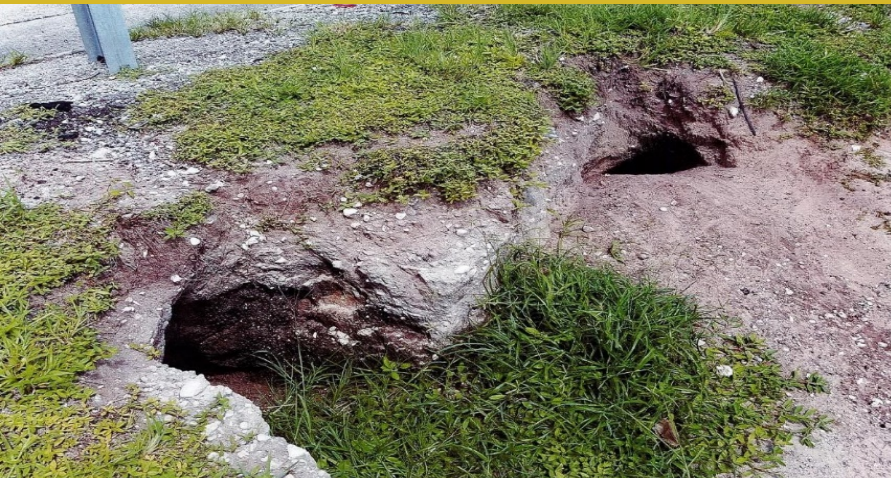
**Two large green iguana burrows along the Florida Turnpike in south Florida. These large burrow entrances are right at the edge of pavement. The burrows likely extend beneath the roadway and could cause the roadway to collapse. These areas have to be repaired as quickly as possible.**

The Florida Turnpike is an expressway system in Florida with a mainline from Miami to central Florida. A portion of this major roadway connector has recently been plagued by the impacts of the invasive burrowing green iguana. They are thriving along the sloped roadway embankments and the canals that run alongside most of the roadway. The iguanas are burrowing at the edge of pavement with potential to cause collapse of the roadway in these areas. The Florida Turnpike even found at least one occurrence of an iguana that dug its way up through the pavement in the center of the roadway. The Florida Turnpike has been diligently identifying burrow locations along the roadway, and between June 2018 and June of 2020 will have spent over \$750,000 repairing these areas with geotextiles and riprap armament. In order to further address the problem, they hired a scientist to help with the research and development of either a management or eradication plan of the green iguana along the Turnpike. Obviously, they cannot armor the entire roadway embankment of the 100 miles of the Turnpike currently being impacted, but even the cost of developing and implementing a management plan is costly.

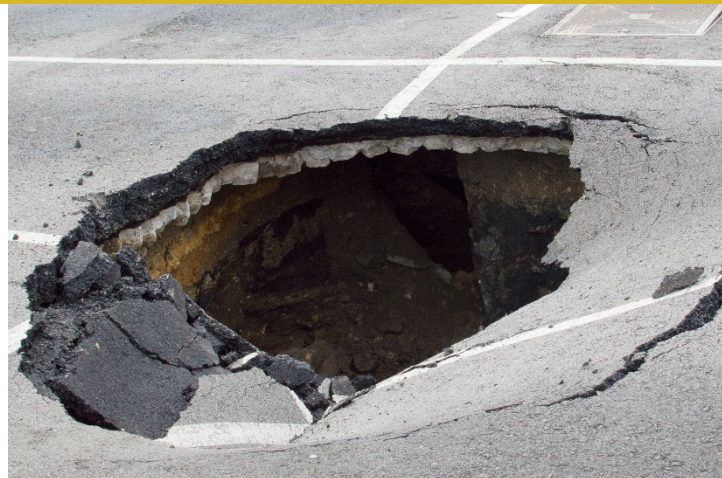
**Above is an example of the type of damage that can occur from an iguana burrow beneath pavement.**

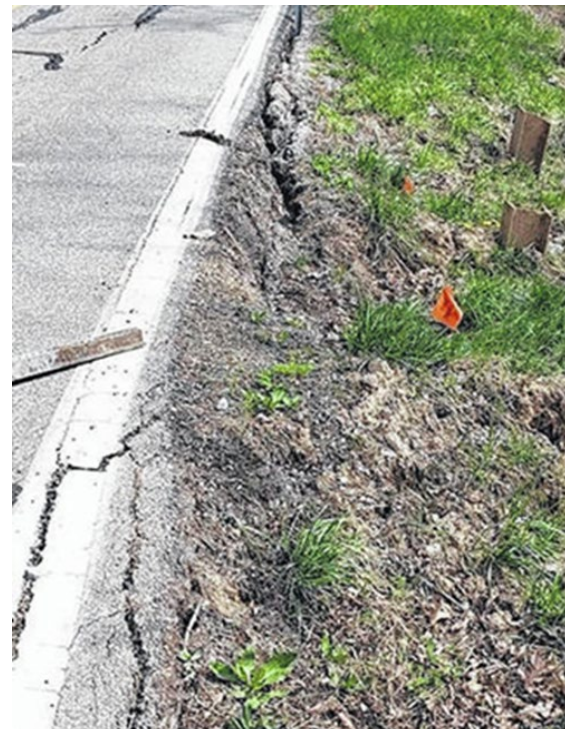
**Roadside embankment erosion can cause pavement cracking.**

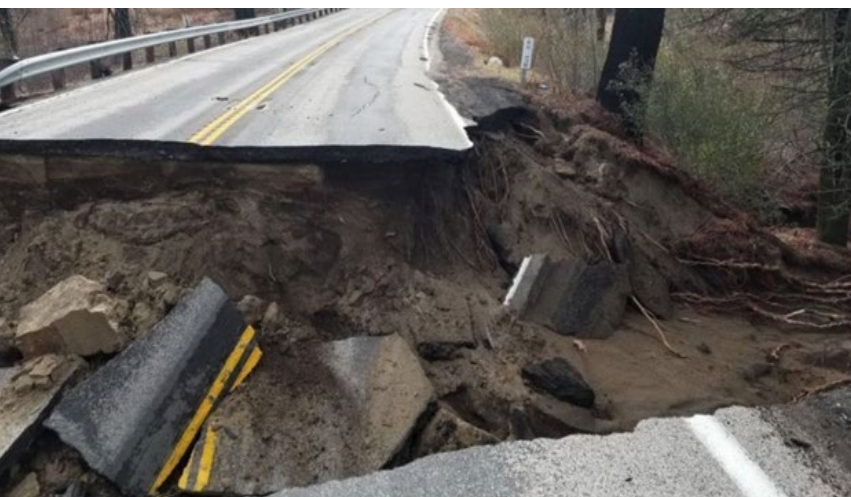
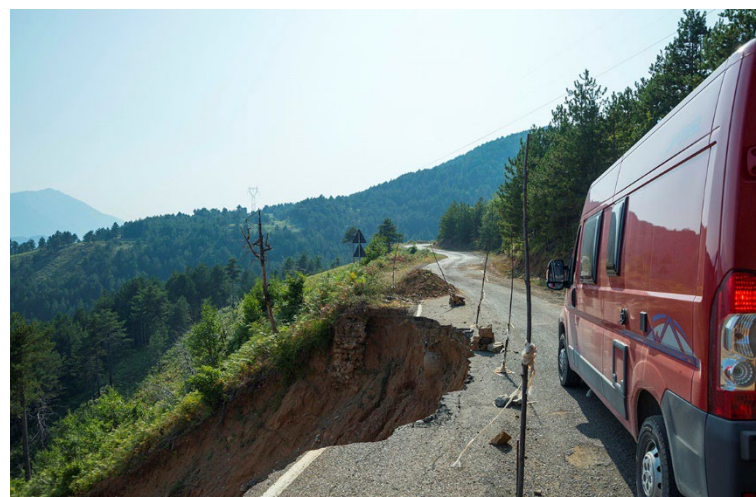
**When soil erosion starts occurring it can get progressively worse and start to erode the soil under the road causing roadway collapse.**

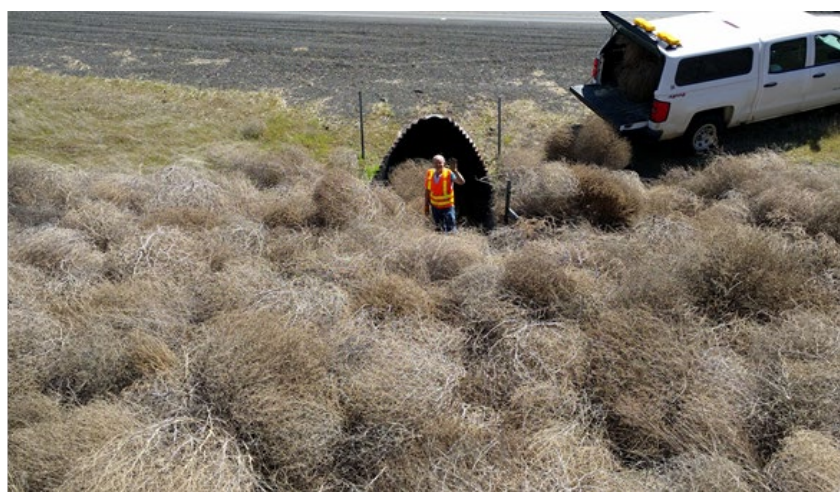
**Tumbleweed blocking a roadway wildlife crossing.**

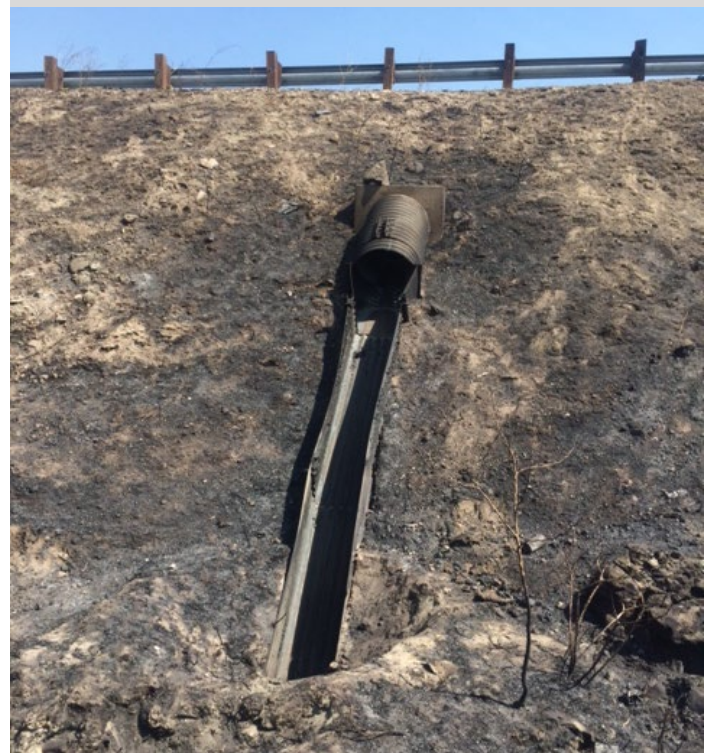
**Culverts and drainage structures can also be damaged by roadside fires and have to be inspected after a fire. The extent of unvegetated loose soil along the roadside embankment shows the potential for serious erosion problems after a roadside fire.**

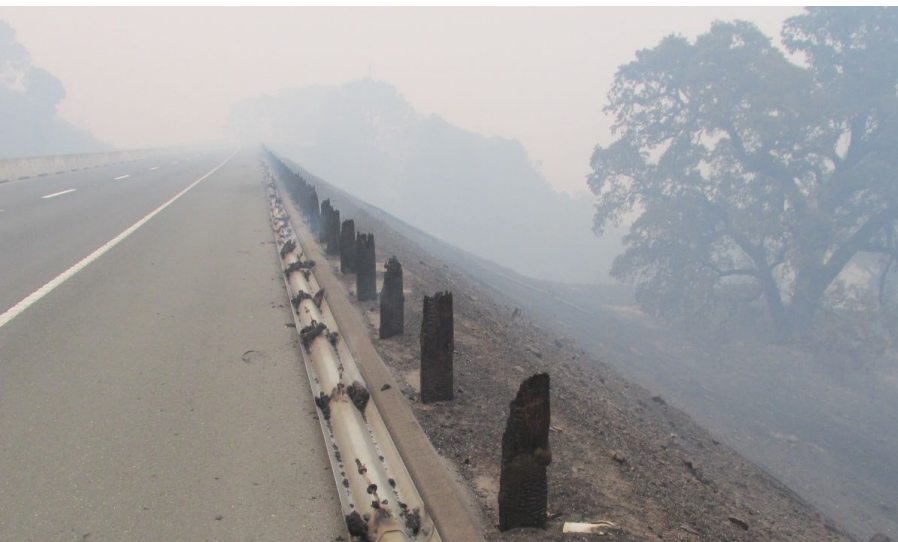
**Burnt guardrail posts and unvegetated, loose soil susceptible to erosion.**

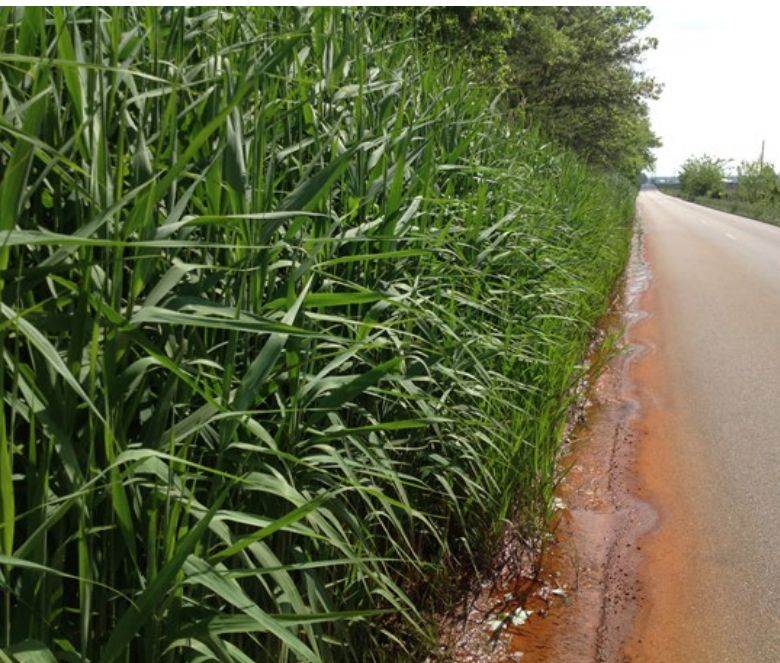
**The density of phragmites prevents water from draining off roads causing flooding in roadway and in the winter creating dangerous ice buildup.**

When plants clog drainage structures such as culverts and ditches, they can cause flooding and ice buildup on roadways, as well as subsequent erosion from flooding. There are many invasive plants across the country that cause these impacts. Examples of such plants include two large invasive reed grasses that are wreaking havoc in waterways in the United States; common reed, also referred to as phragmites (*Phragmites australis*), and giant reed (*Arundo donax*). Some State DOTs report that phragmites is the most aggressive, impactful, and difficult to manage invasive species in their right-of-way. Both species create dense populations along riversides, stream channels, and ditches and both grow over 15 feet tall. They are fast growing and spread quickly by rhizomes, which are creeping rootstalks. They outcompete and displace native vegetation, and their fibrous, dense root mats build up sediment and debris, thus blocking drainage and water flow patterns. They act as dams impeding flow through bridges, culverts and other drainage structures and cause flooding behind it. Not only do they cause significant flooding issues, but they are extremely flammable, which is a major problem in the western United States where the fire regime is more severe and giant reed is prevalent. Their size and density blocks sight lines along roadways, obstructs signs, obscures edge of pavement, and can literally swallow a car. They are attributed to DOT tractor mower rollovers because they obscure visibility and slope grade along the right-of-way.

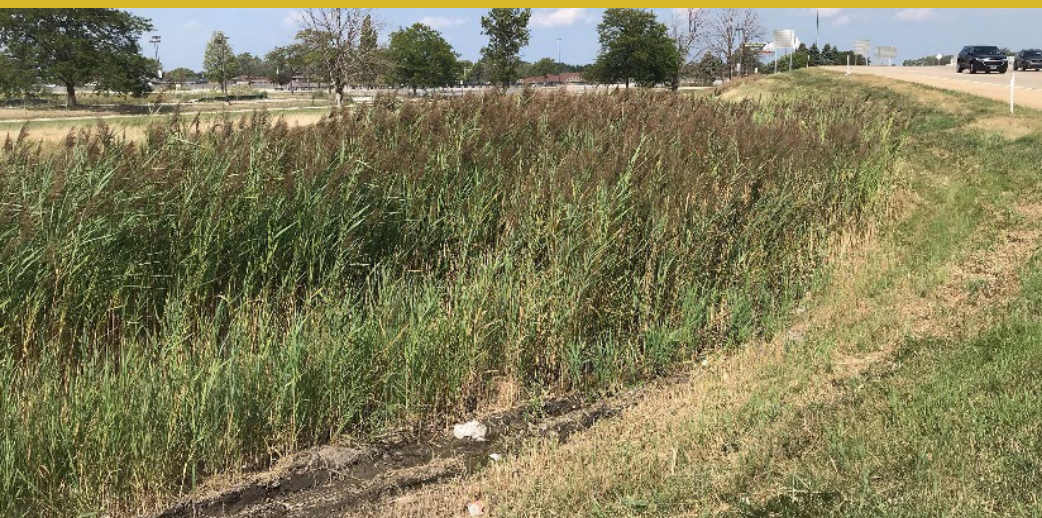
**Phragmites has taken over this interstate infield which is likely used for stormwater drainage. The sloped embankment and the plant size and density make it difficult and dangerous to mow.**

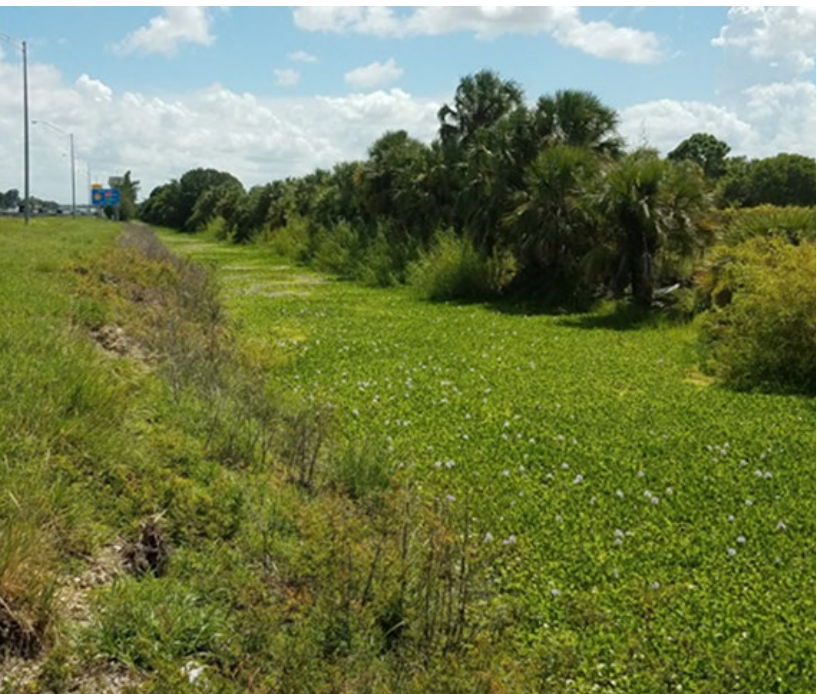
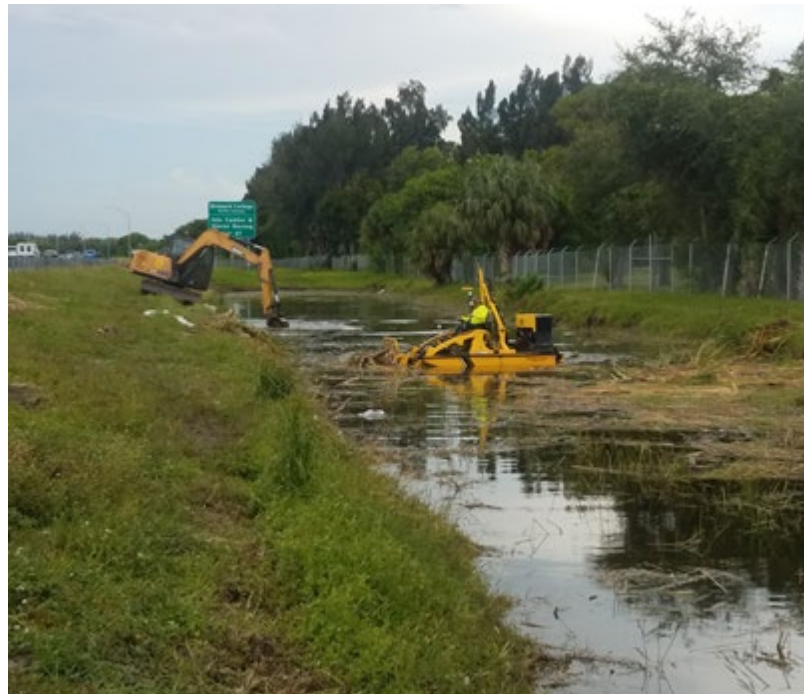
**Before and after images of mechanical removal of water hyacinth from a stormwater management ditch along the Florida Turnpike.**

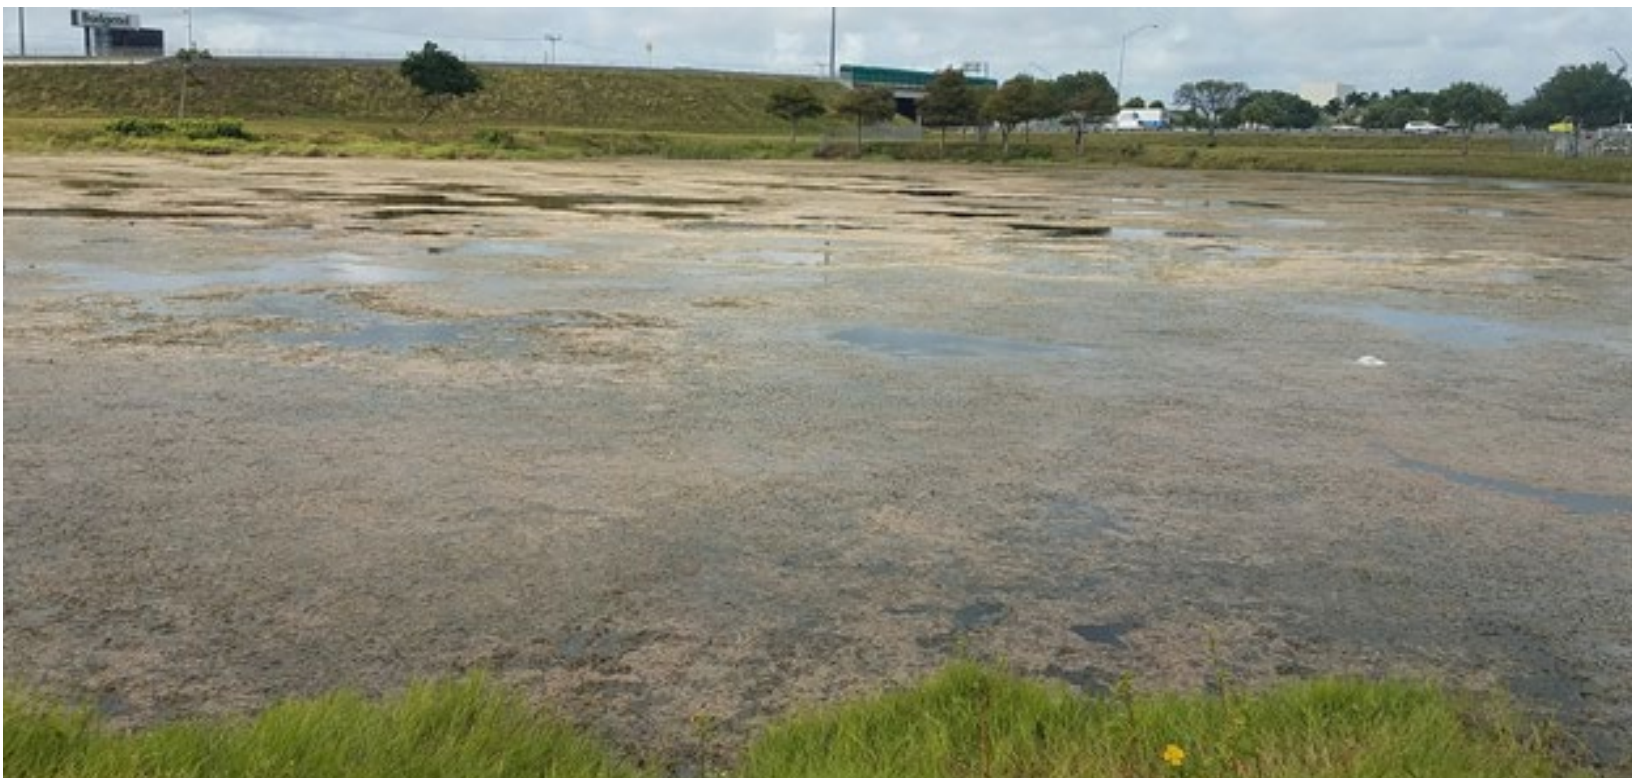
**A stormwater pond that captures stormwater from the Florida Turnpike filled with hydrilla.**
